# Compatibility Problem with Windows XP SP3

Revision 1.0

Date: May 22, 2008

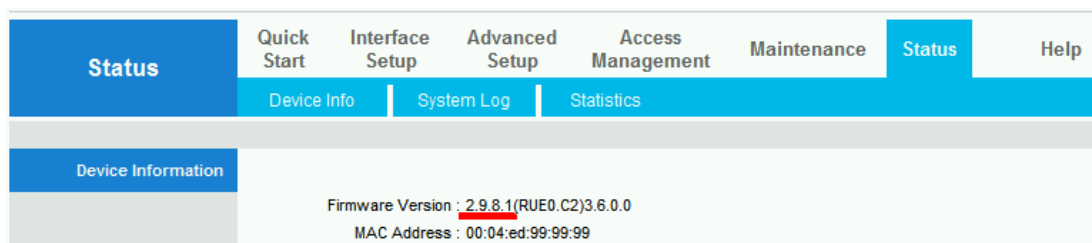
1. Log on to WEB GUI.
2. Check Firmware Version on Device Info page. The affected firmware version of BiPAC 5200 series are 2.9.8.x and 2.11.0.x~2.11.33.x.
